# Learning from Texas Wildfires: Bastrop State Park and Beyond

Funded by a grant for the  
National Park Service's Center  
for Preservation Technology  
and Training

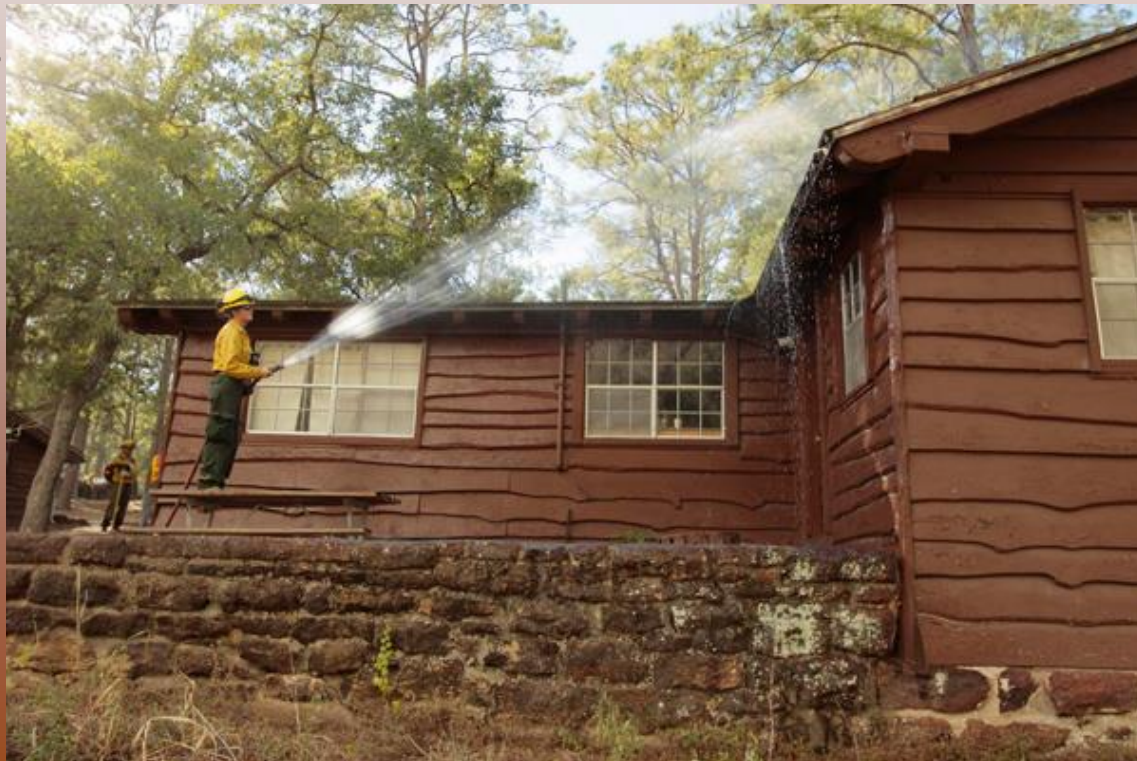
- Park firefighters had time to remove pine needles from roofs and douse them with water, as well as dig fire breaks around cabin areas.

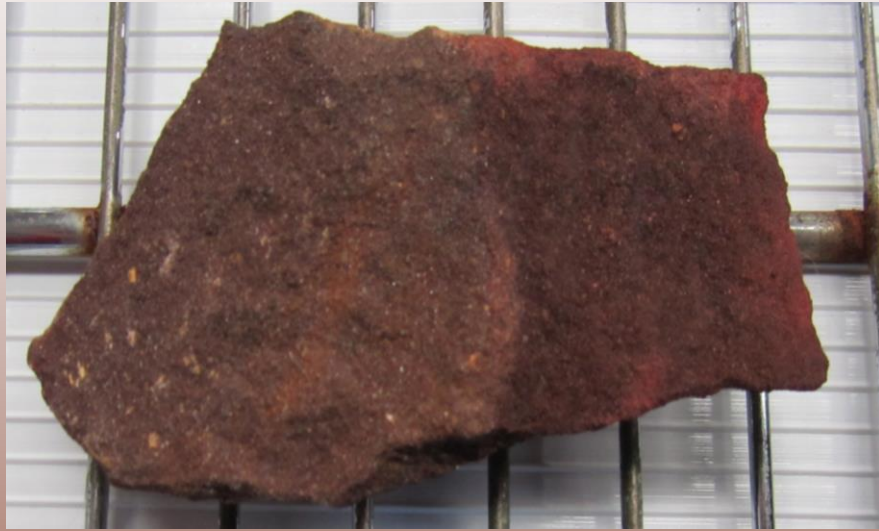
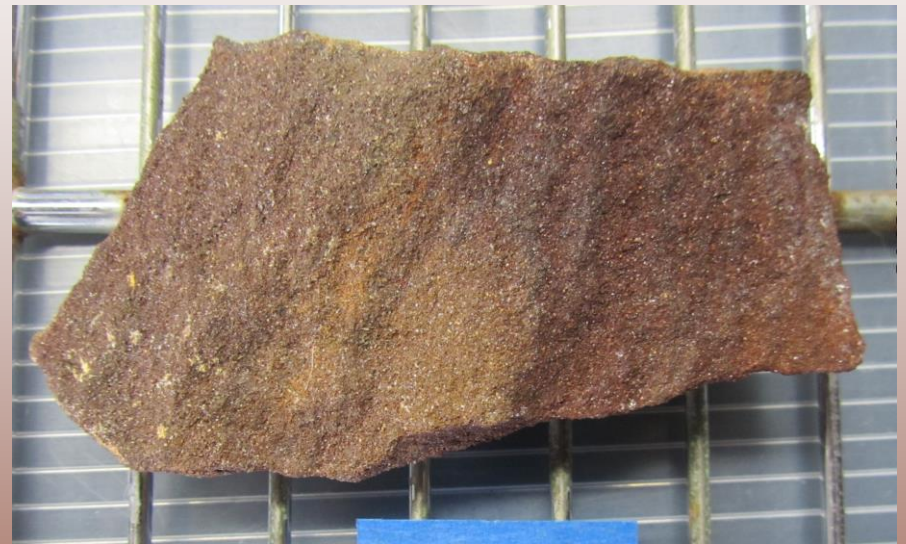
- UT Team conducted laboratory testing of retardant removal
- Using BSP samples, retardants were applied and exposed to 100° temperatures for several days.
- Water washing was effective in removing most retardant, mild detergents removed remaining product
